Failure Analysis of Hydraulic Cylinders in Speed Lift Accident by Beacon Forensic, P.C.

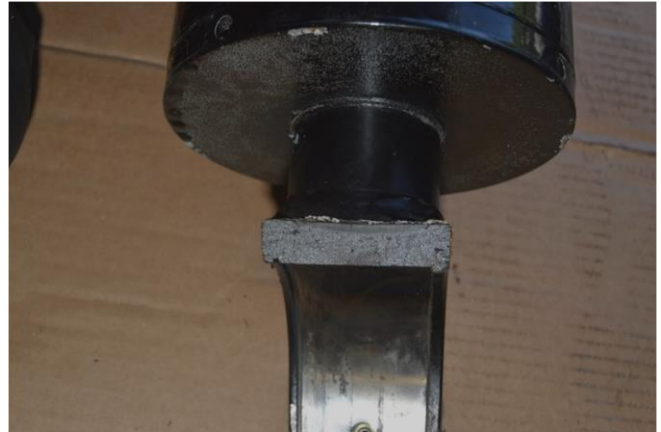
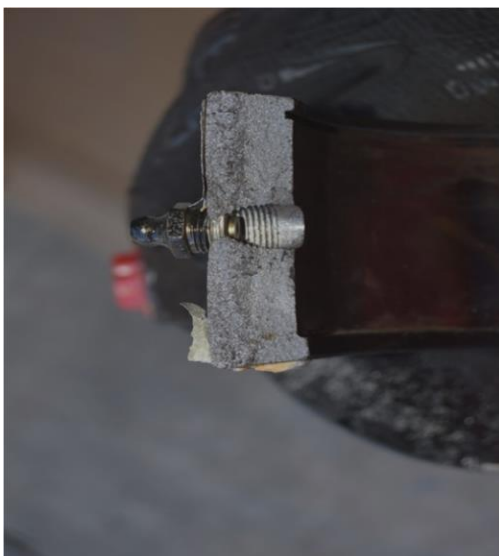
The engineer conducted a failure analysis to determine the cause of the incident. During the investigation, the engineer researched specifications and equipment manuals for the speed-lift as well as specifications for the hydraulic cylinders and completed calculations for lift weight loads. The weld was inspected by a material scientist using the latest technologies to reveal an abnormality in the weld.

Based on the investigation and research, it was concluded that at the time of the failure, the lift was not overloaded. Due to defective welding during the manufacturing process, the weld on one of the cylinders failed when it experienced high stresses. Once the incident weld failed, the remaining cylinder had to support the weight of the lift platform and its contents. After a period of time, the additional weight exposed led to further deformity and fractures, and subsequently failed, causing the raised platform to drop during operation. It was also determined that the supplier of the speed-lift failed to correctly install the equipment before selling the unit.
